Police Workshop Technical Newsletter 41

D-TPMS Service required message, Fault tracing due to DTC on all models MY15-

Knocking noise from rear suspension, loose spring aid in upper spring seat on S60/V60/XC60/V70 & XC70 MY11 models

Door mirror, play in mirror assembly on V40/V40CC/S60/V60/V70/XC70 & S80 models

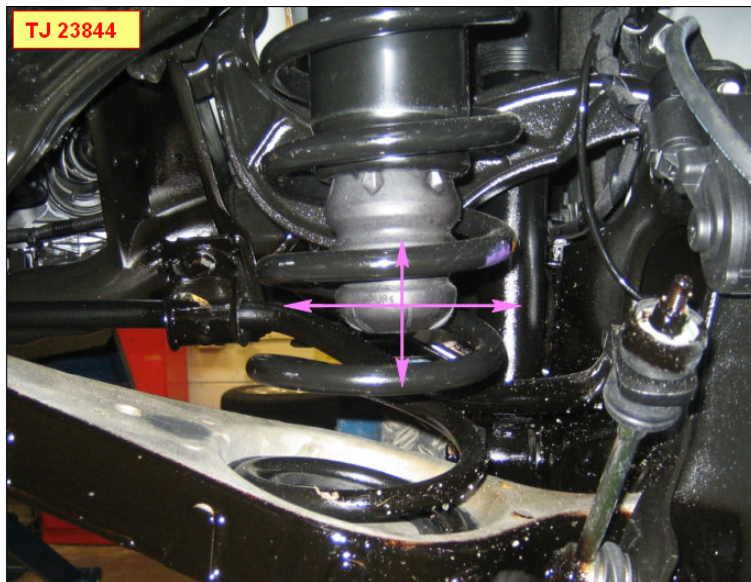
There may be a knocking noise from the rear spring aid (bump stop rubber) if the spring aid is loose in the upper spring seat installation on S60, V60, XC60, V70 & XC70 MY11 models. Please see SERVICE below service solution.

Verify the symptom by wiggling on the rear spring aid (see picture 1 below).

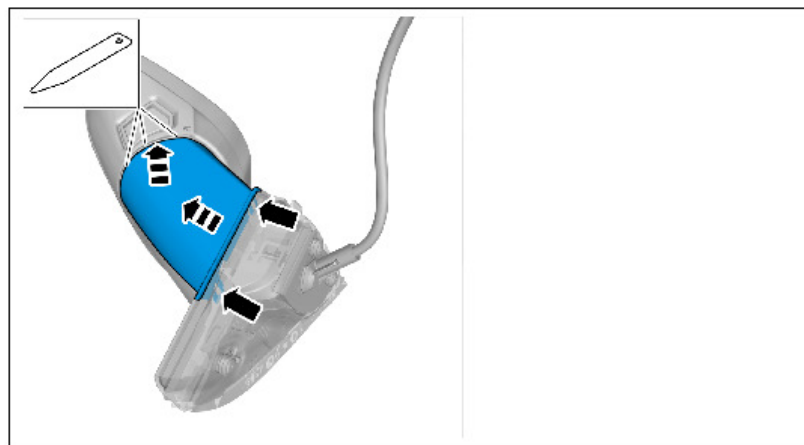
Customer may experience play (tilting up/down, y-axis) in the outer door mirror assembly on V40 & V40CC MY13-, S60 & V60 MY11-, V70 MY08-, XC70 MY08- and S80 MY07- models.

Remove rear-view mirror external , refer to:
 Removal, replacement and installation
 8 - Body and interior
 84 - Exterior trim, glass, weatherstrips
 846 - outside mirrors
